Transmission Facility Outages During the Northeast Snowstorm of October 29–30, 2011

Causes and Recommendations

Prepared by the Staffs of the
Federal Energy Regulatory Commission *and* the North American Electric Reliability Corporation

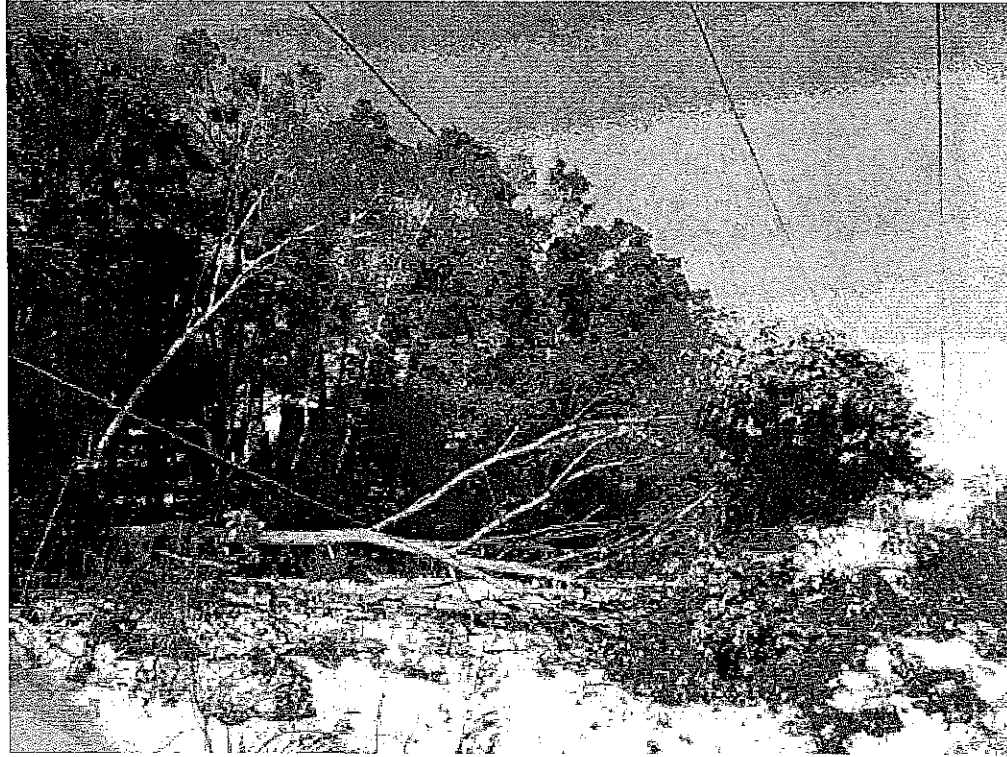
Figure 13: Trees Fallen on 115kV Line in Connecticut

The 115 kV line in the photograph below was forced out of service when several trees, each over sixty feet tall and located twenty to thirty feet outside of the utility's full right-of-way, uprooted and fell onto three separate spans of the line. Transmission lines are not always located in the middle of a right-of-way, but instead often are closer to an edge of the right-of-way. Thus, as is the case here, a tree may be outside the boundaries of a 130 foot wide right-of-way but still less than sixty-five feet from a conductor.

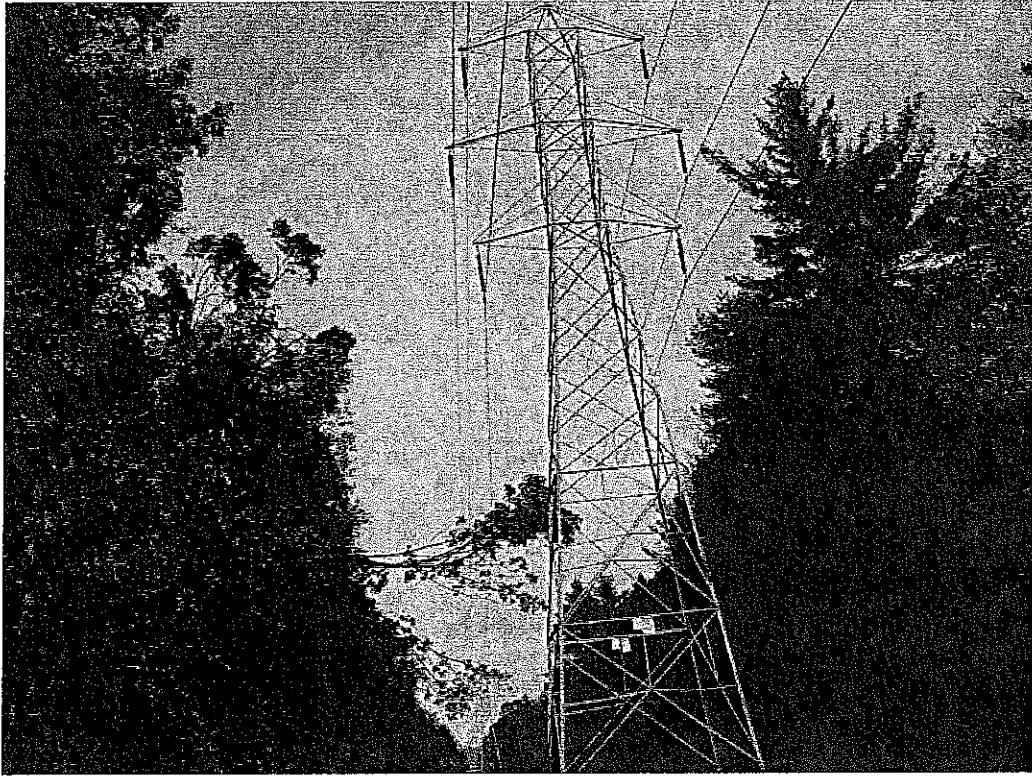
Figure 14: Tall Tree Fallen on an 115kV line in Massachusetts

The line in the photograph below is a 115 kV line in Massachusetts that went out of service when a seventy-five foot tall tree located outside of the 100 foot wide maintained right-of-way, but inside the 200 foot wide full right-of-way, fell onto the line. Because the transmission line was not centered on the right-of-way, the base of the tree, while outside the maintained right-of-way, was only about 30 feet from the nearest conductor.

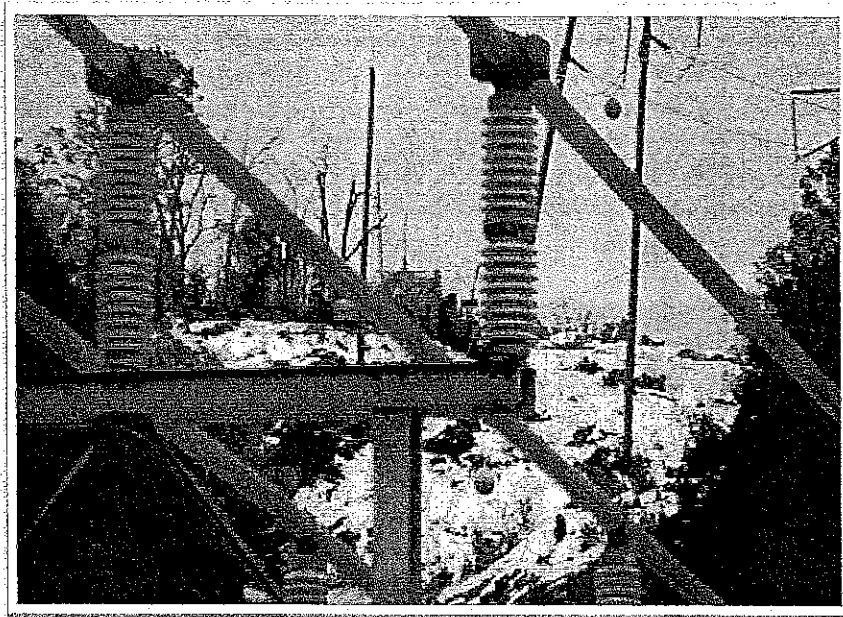
Figure 15: Structure Failure on a 345kV Line in Connecticut

Extreme weather conditions caused several transmission facilities to break, resulting in transmission line outages. Temperatures during the snowstorm hovered around 32 degrees, which is conducive to the accumulation of ice and snow on transmission lines. The weight of the accumulated ice and snow on conductors, and, in one case, high wind conditions, caused a number of structures — including static wires,⁶⁶ conductors, insulators,⁶⁷ and cross-arms⁶⁸ — to break, resulting in six transmission line outages and approximately 32,000 customer outages. Although a number of the transmission structures that failed were several decades (or even more than fifty years) old, it does not appear, based on data obtained during the inquiry, that these structures were in need of repair before the storm. Data reviewed by staff also indicates that the affected structures had been maintained according to utility plans, which staff finds are consistent with typical utility practice.

The 345 kV line shown in the photograph above was forced out of service when the weight of ice and heavy, wet snow on conductors damaged a structure and broke a conductor, static wire, cross-arms, guy-wires,⁶⁹ and insulators. This photograph shows (in the background) a wood pole where cross-arms and guy-wires have broken and the conductor has fallen to the ground.
